LOWER WARWICK RESERVOIR DAM
ORANGE COUNTY NEW YORK
INVENTORY NO. 59

PHASE I INSPECTION REPORT
NATIONAL DAM SAFETY PROGRAM

Prepared by: NEW YORK DISTRICT CORPS OF ENGINEERS
Date: SEPTEMBER 1978

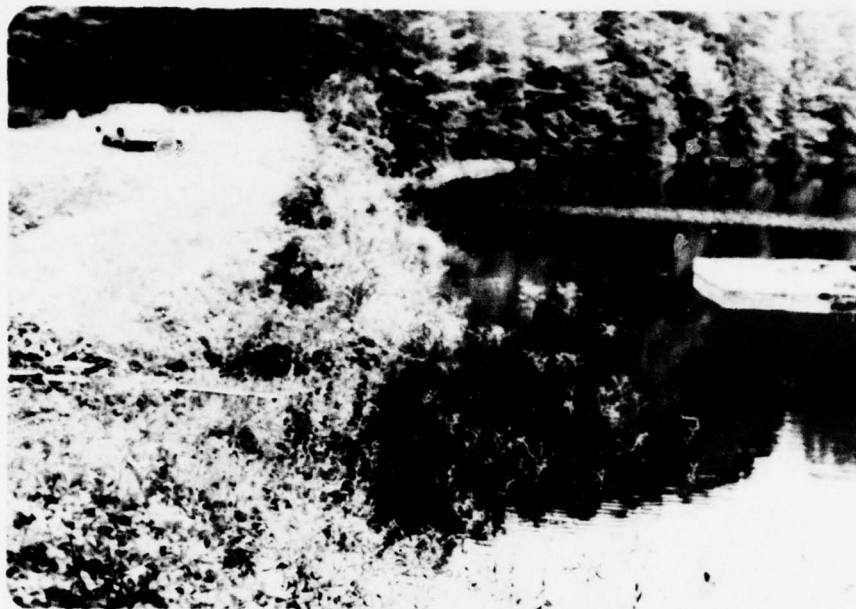
**VIEW ALONG CREST OF DAM LOOKING EAST
(NOTE ABANDONED OUTLET STRUCTURE)**

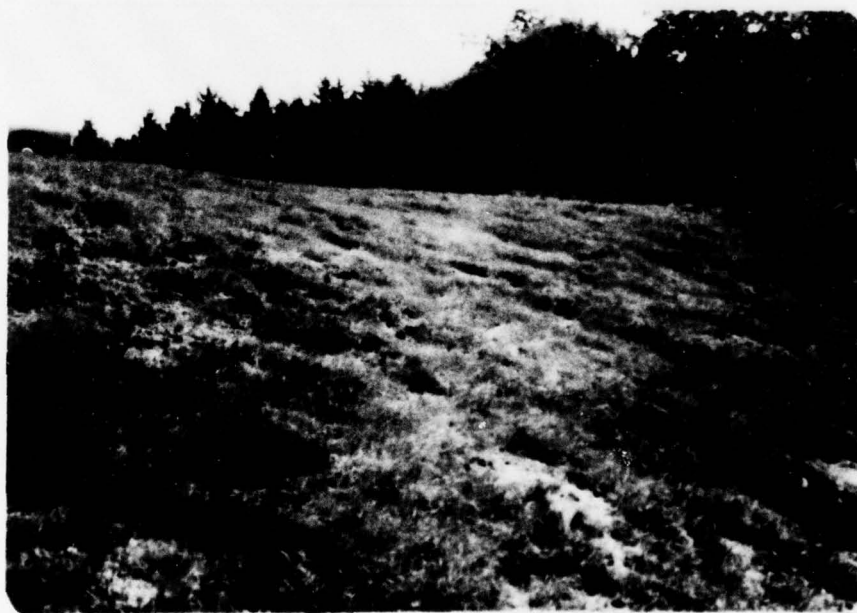
DOWNSTREAM FACE OF NEW EMBANKMENT SLOPE

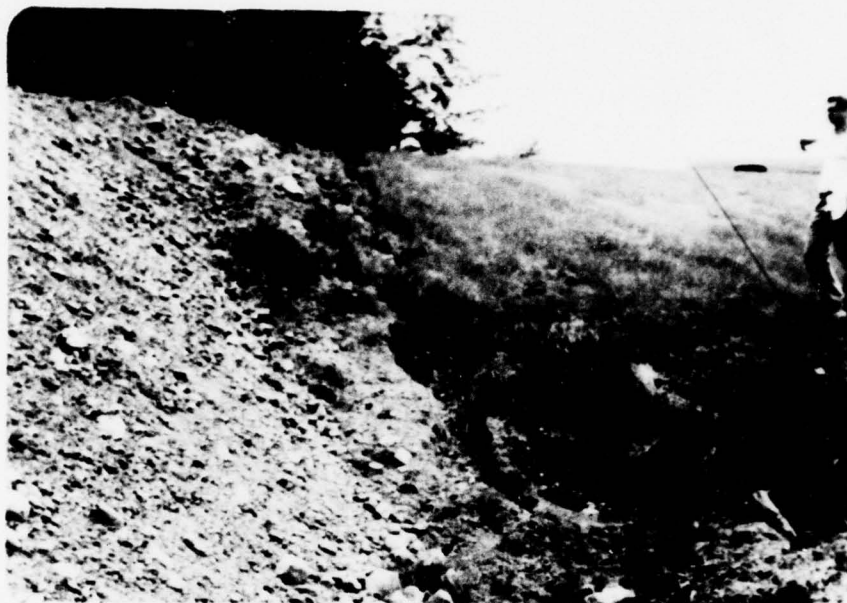
EROSION ON DOWNSTREAM EMBANKMENT SLOPE

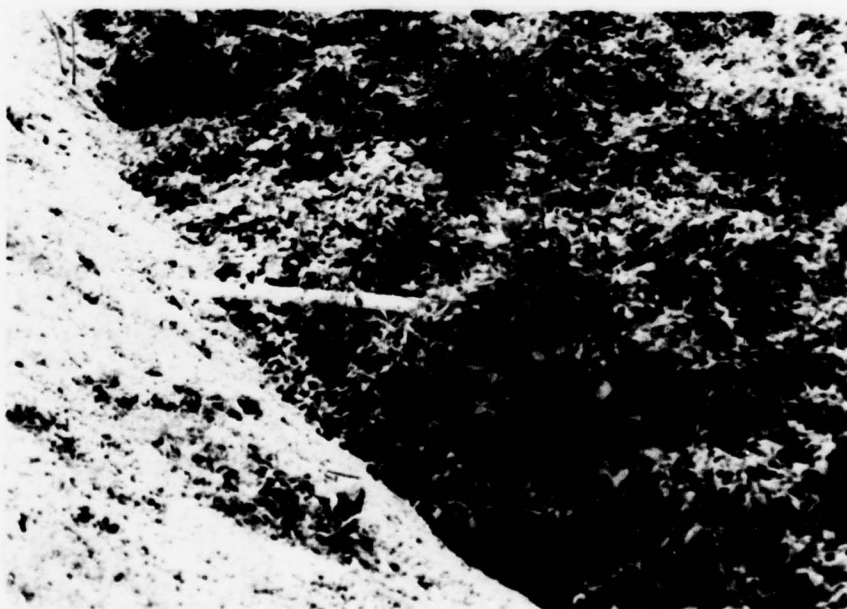
OUTLET PIPE FOR TOE DRAINAGE

d. Post Construction Changes. Repairs on the western portion of the downstream embankment slope were completed in the spring of 1978. The recently placed toe drainage facility is not passing water, indicative that the impervious blanket placed on the upstream slope in this area is functioning as anticipated.

4. The toe drainage facilities should be inspected and flow noted at weekly intervals.

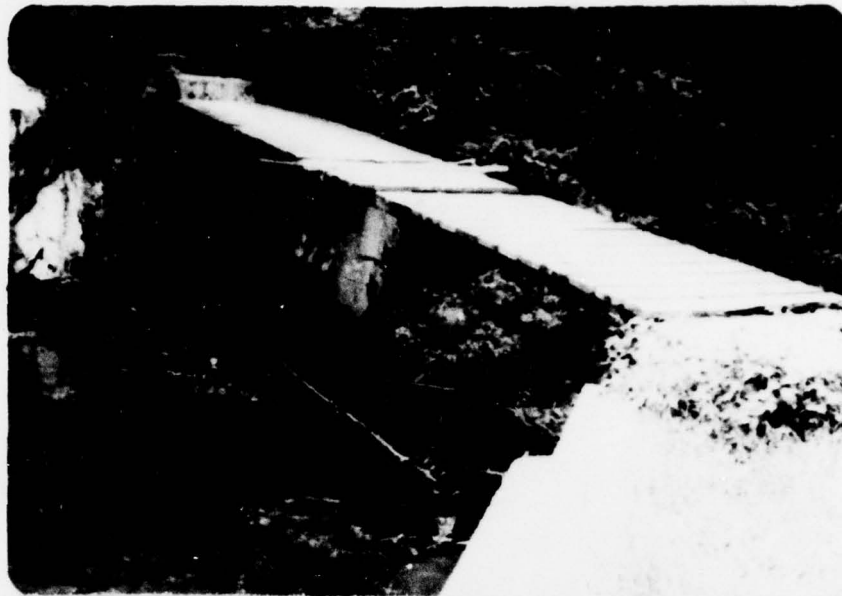
OVERVIEW OF SPILLWAY

d. Spillway. The spillway, located at the west abutment is a concrete gravity section 25 feet in width. Two to three inches of water was flowing over the spillway at the time of inspection. The concrete appeared to be in good condition with minor surface scaling. There is no evidence of structural cracking. The spillway is cut into bedrock and the west abutment contact is in rock. No evidence of distress was evident.

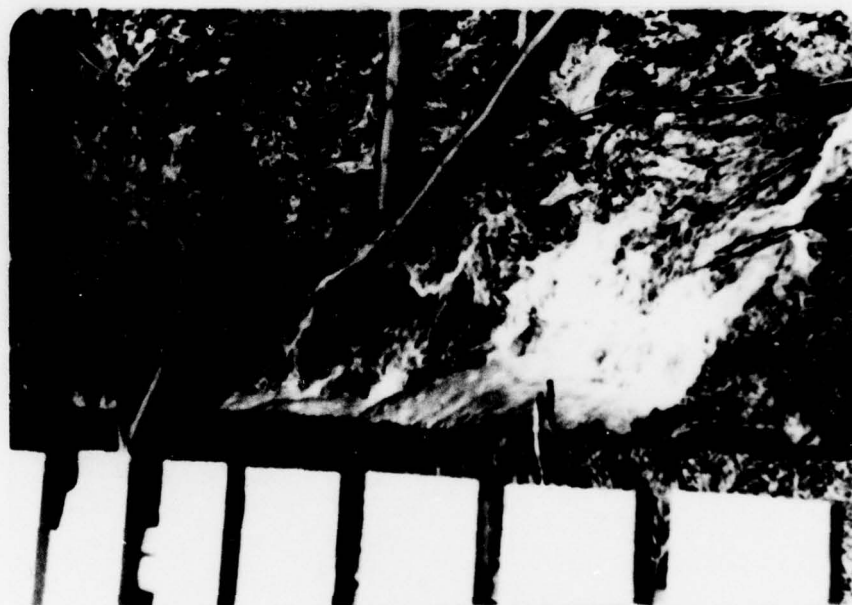
DOWNSTREAM FACE OF SPILLWAY AND
ROCK CHANNEL

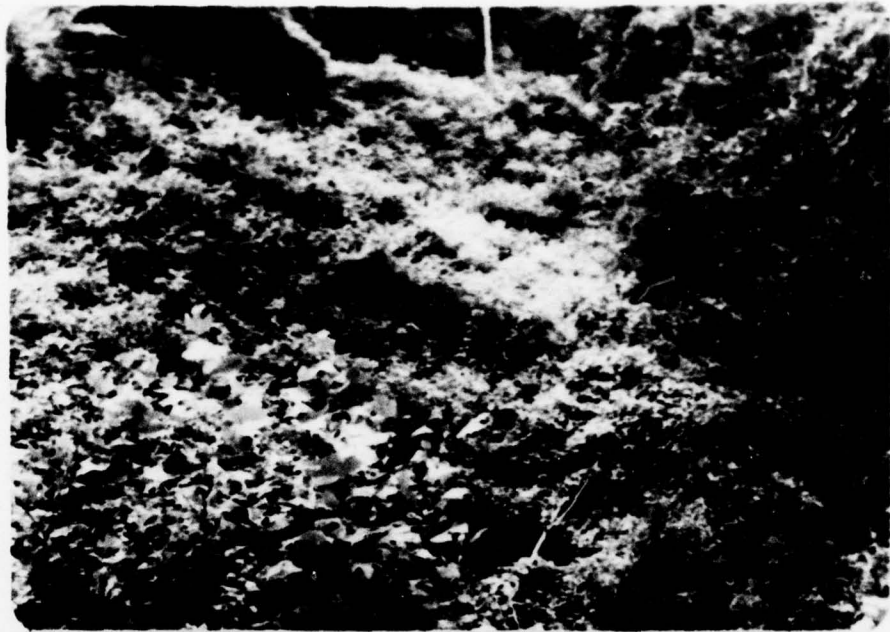
WESTERLY PORTION OF DOWNSTREAM EMBANKMENT SLOPE

Heavy brush and growth on approximately one-half of the downstream slope made this area inaccessible. The remainder of the embankment and spillway are maintained in satisfactory condition by village personnel.

Mr. Quackenbush, Supt. of Public Works for the Village of Warwick, informed the inspection team that the western half of the downstream slope will be cleared during the winter of 1978-79. The remainder of the dam is maintained in satisfactory condition.

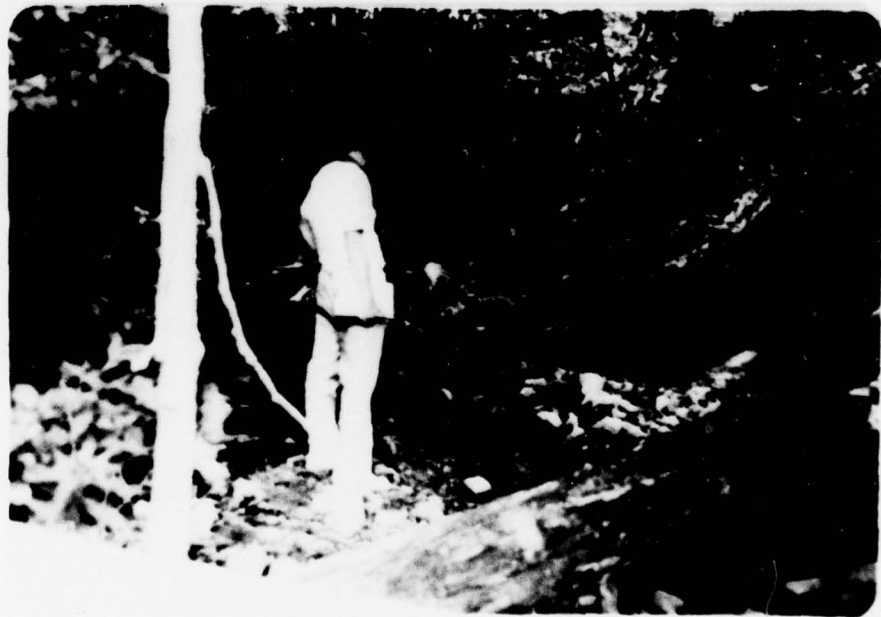
DOWNSTREAM CHANNEL BELOW SPILLWAY
